With this letter we wish to express our opinion about the MERUS ring installed on mv Slingeborg.

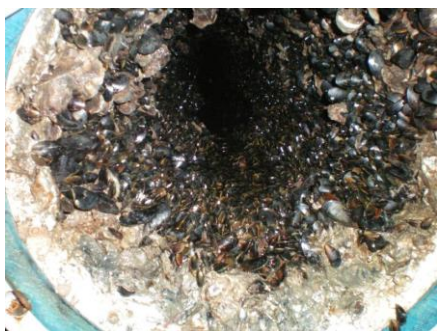
Due to the lay out, the 25 meter long suction line from the cross over to the engine room was full of mussels almost every year. We have tried (and still are..) using various chemicals and cathodic protection. But no significant improvement as result. In the best case the fouling with mussels was extended over 2 years in stead of 1 year. At high cost of chemical dosing and a lot of problems with coolingwaterflow.

Typical at end of season

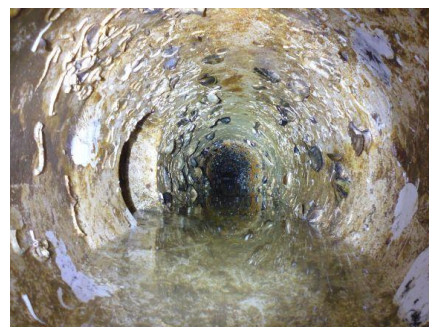
In November 2013 we became aware of the MERUS ring concept, we decided to install such a ring on the sea water inlet before the sea water filter. After one year our preliminary conclusion is that it has a positive effect on the sea growth in the sea water suction line towards the engine room. Where we before had a drop in suction pressure before the sea coolingwater pumps, we now still have a positive suction pressure, even with a big Drencher pump working. Below are some pictures to prove the above mentioned. Left is the typical condition we find the pipe in after one or two years, right was the condition last November 2014.

November 2014 > 1 year with ring
